EXHIBIT 2

Ref: Vacant Sears Store Roof Inspection

Site Inspection Report

Site: Cross County Shopping Center
Location: Sears Lower Level

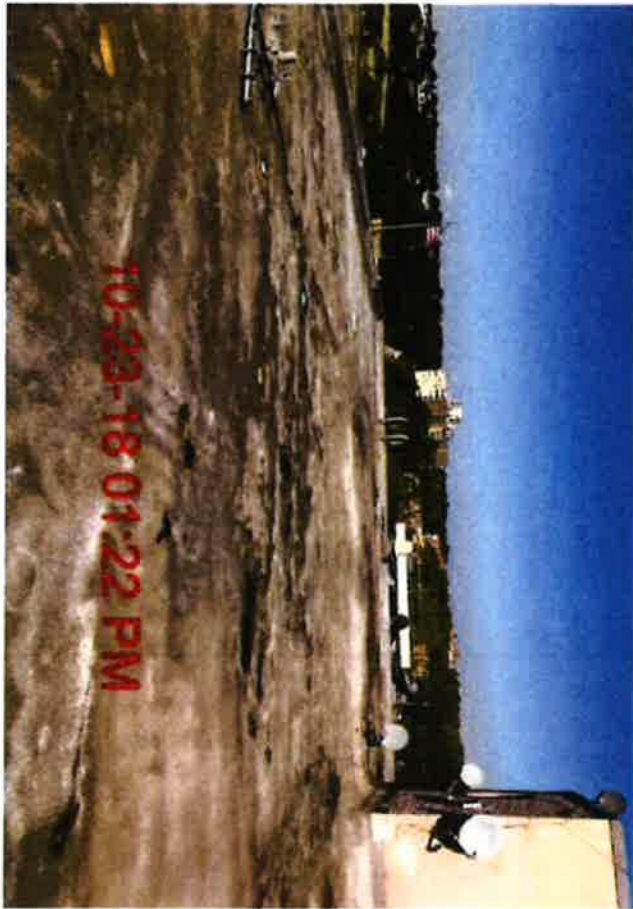
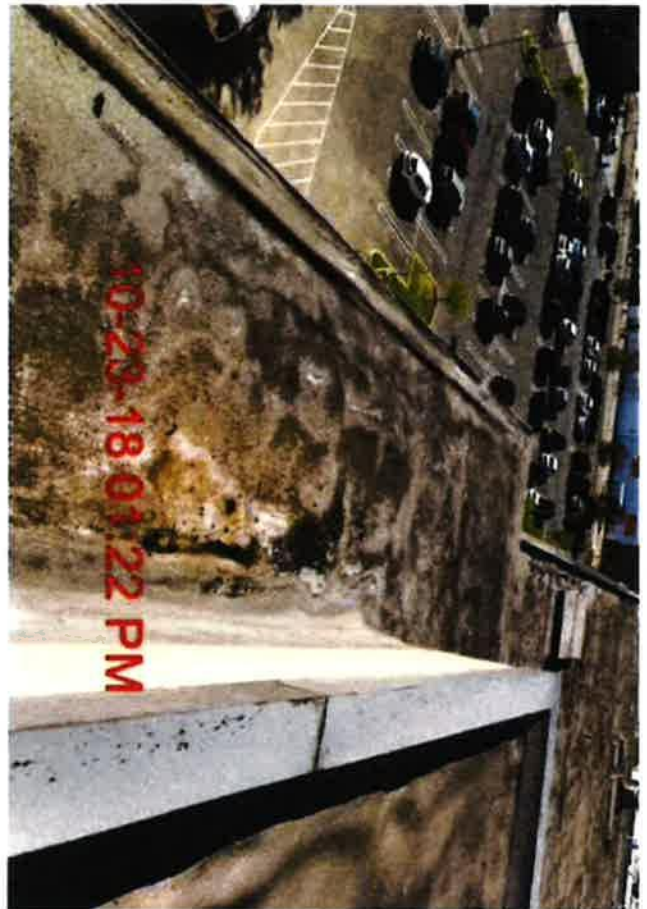
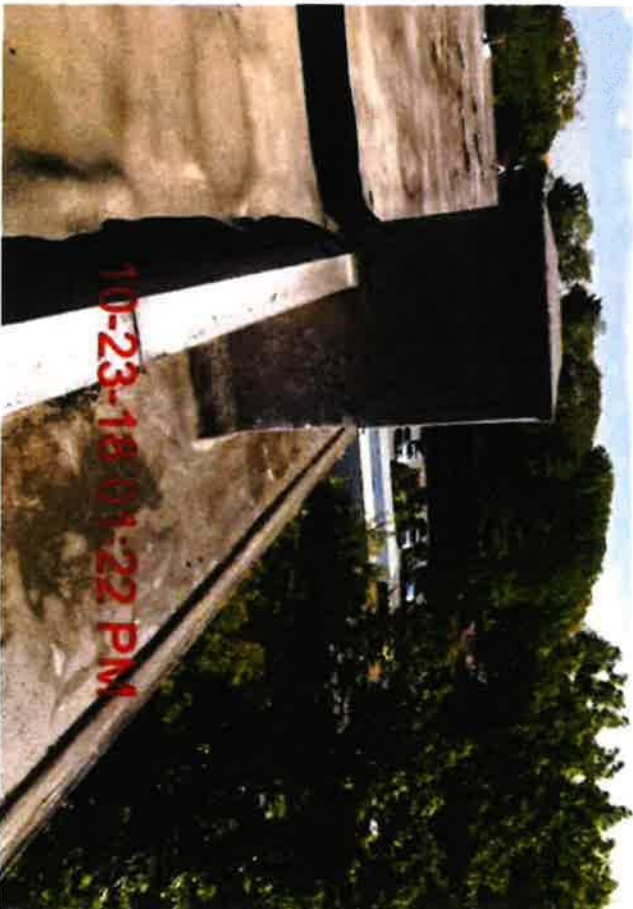
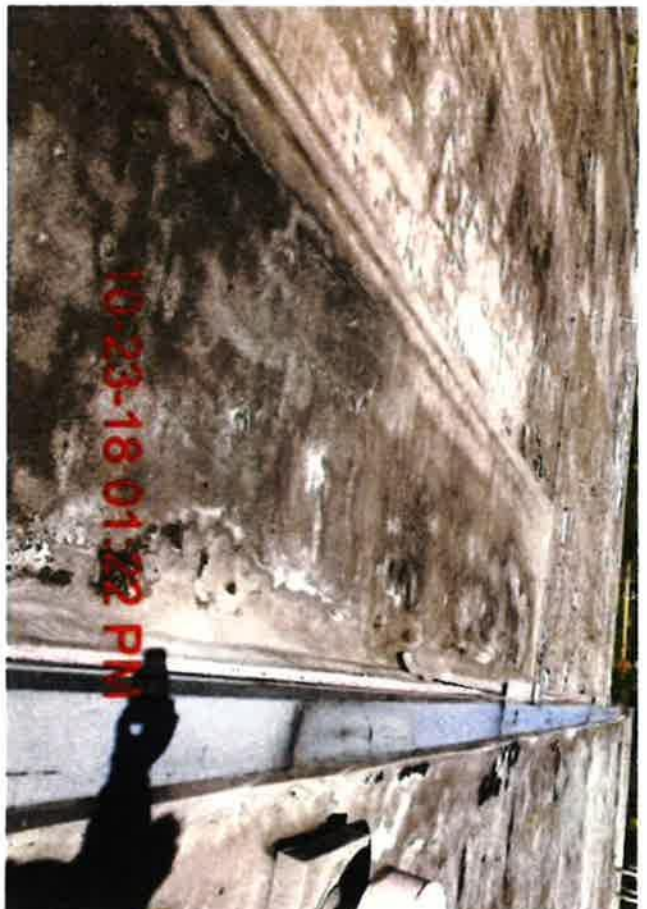
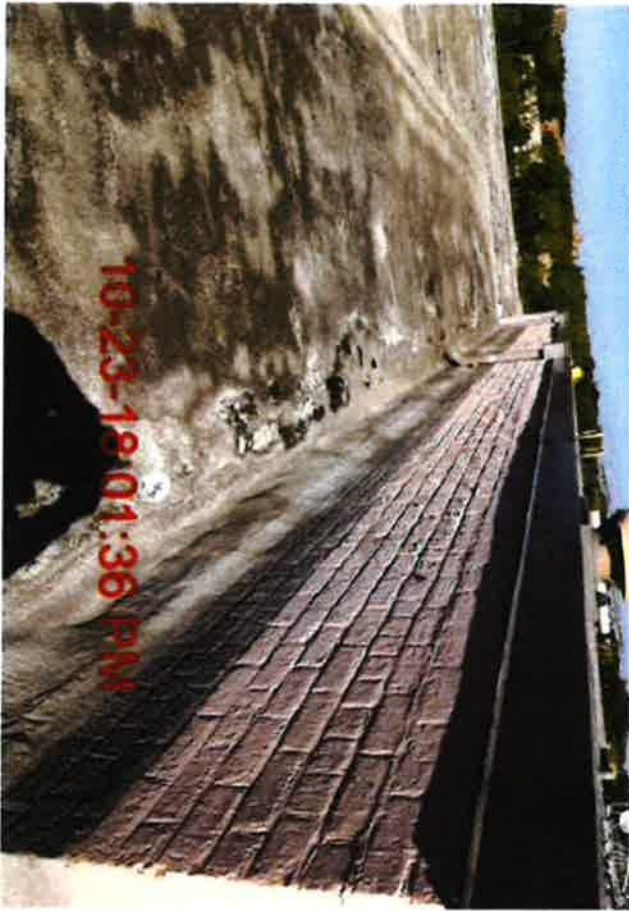
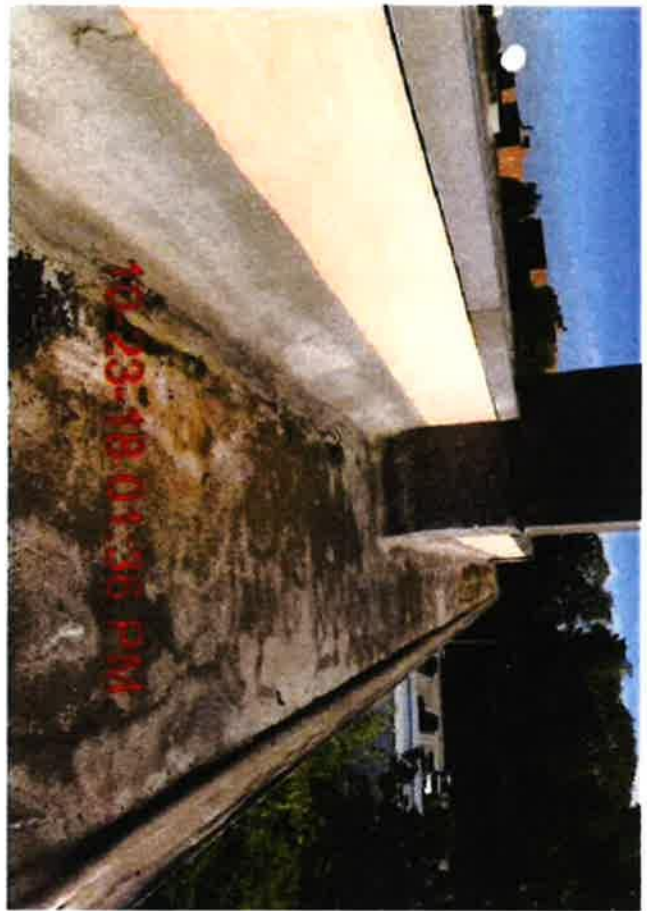
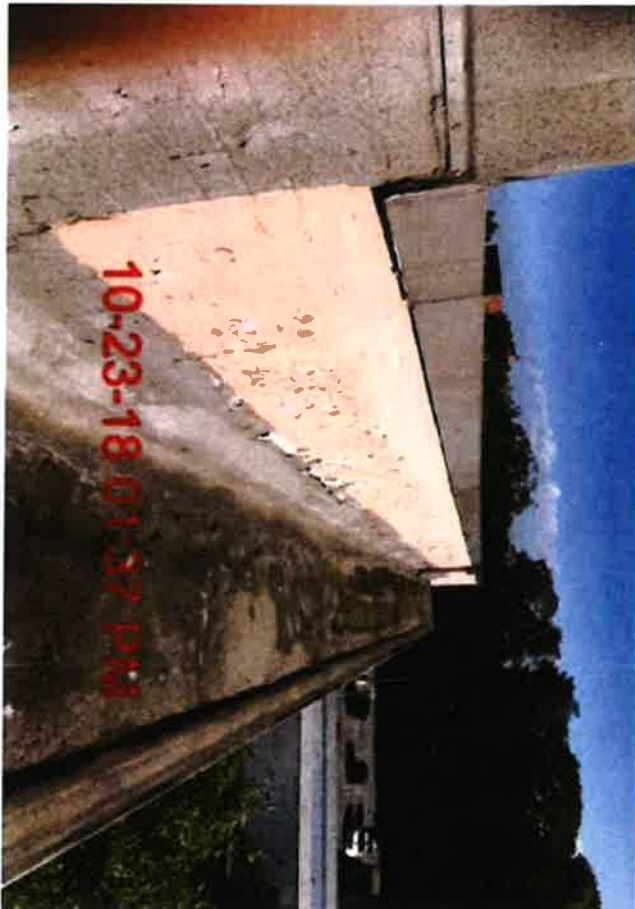
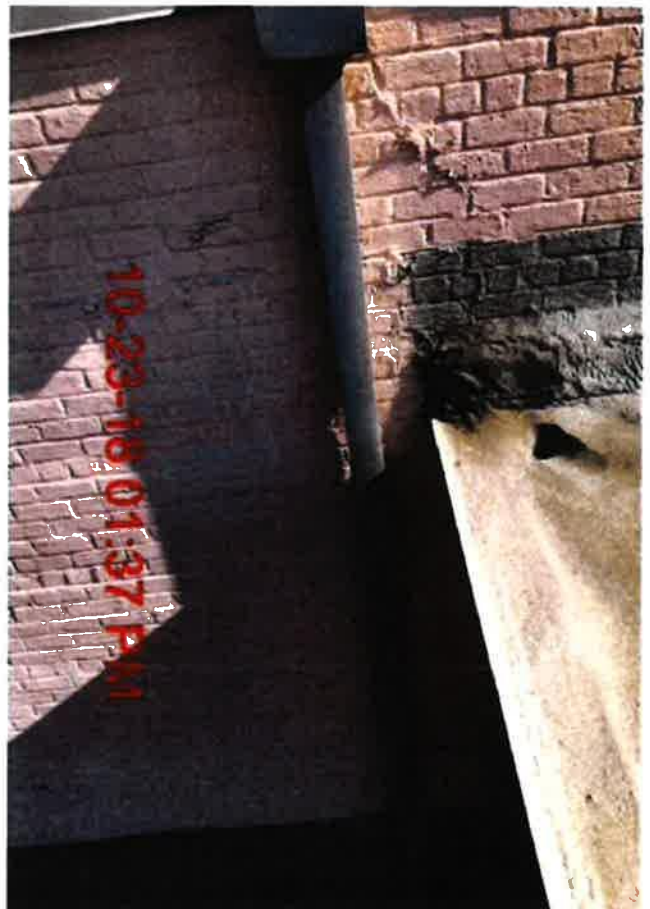
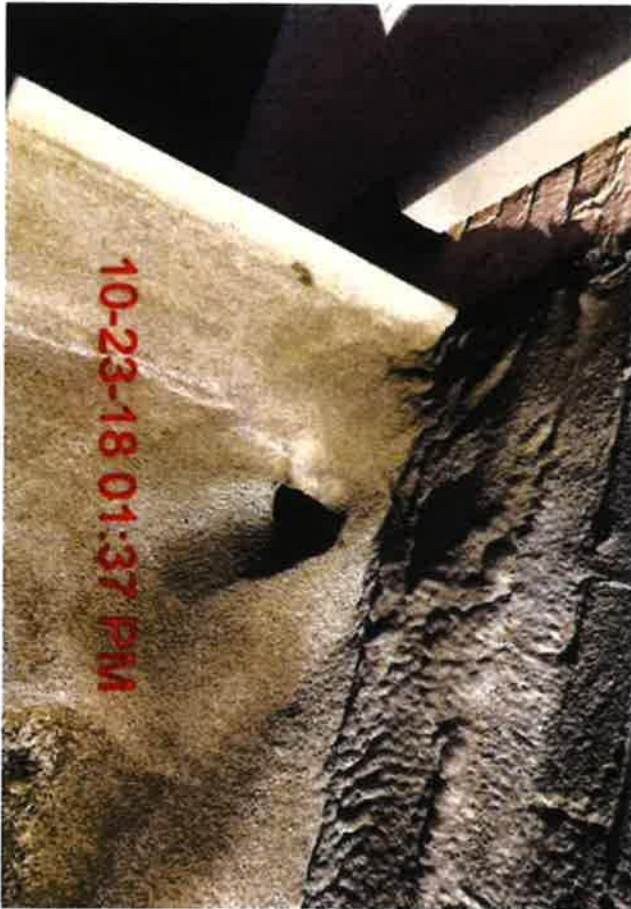
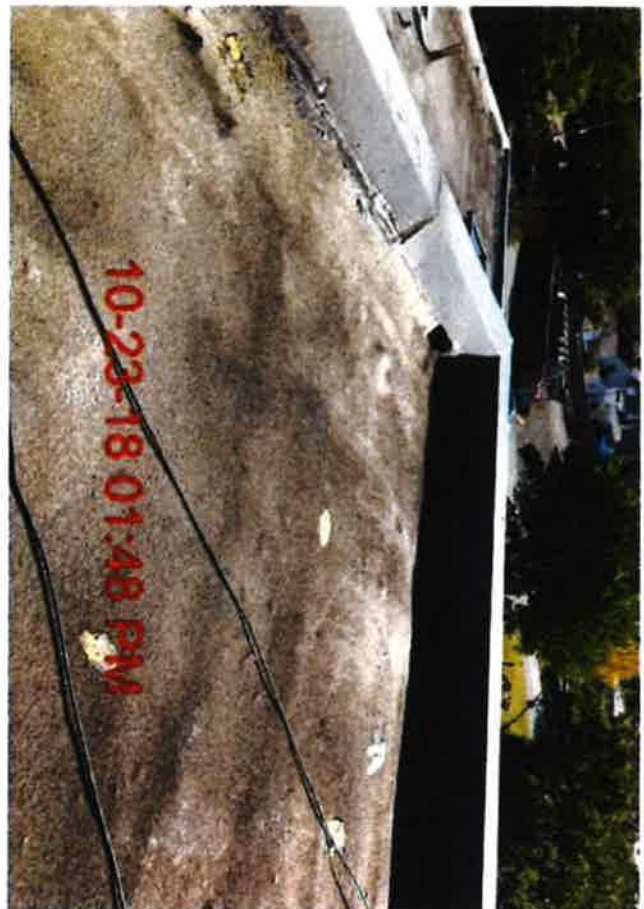
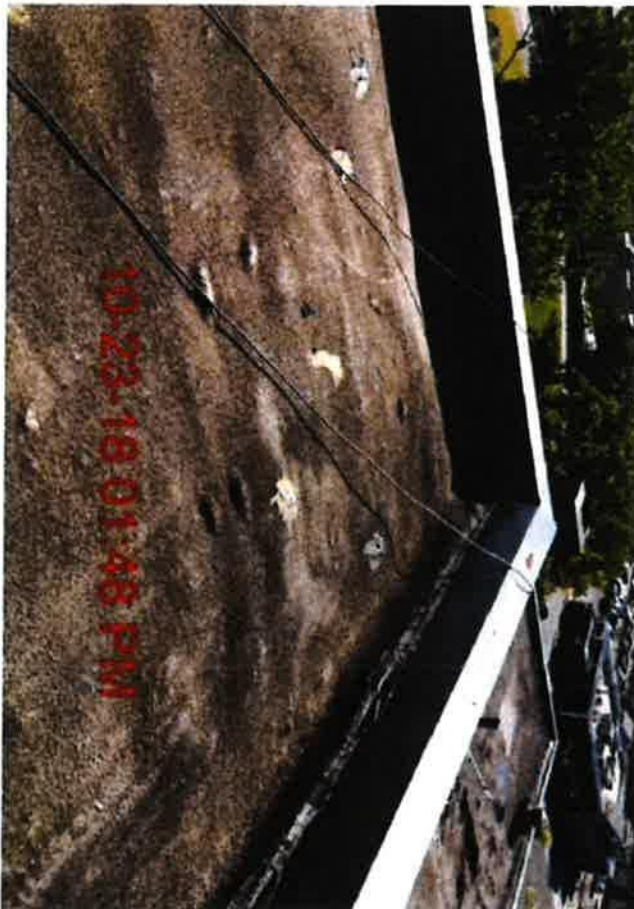
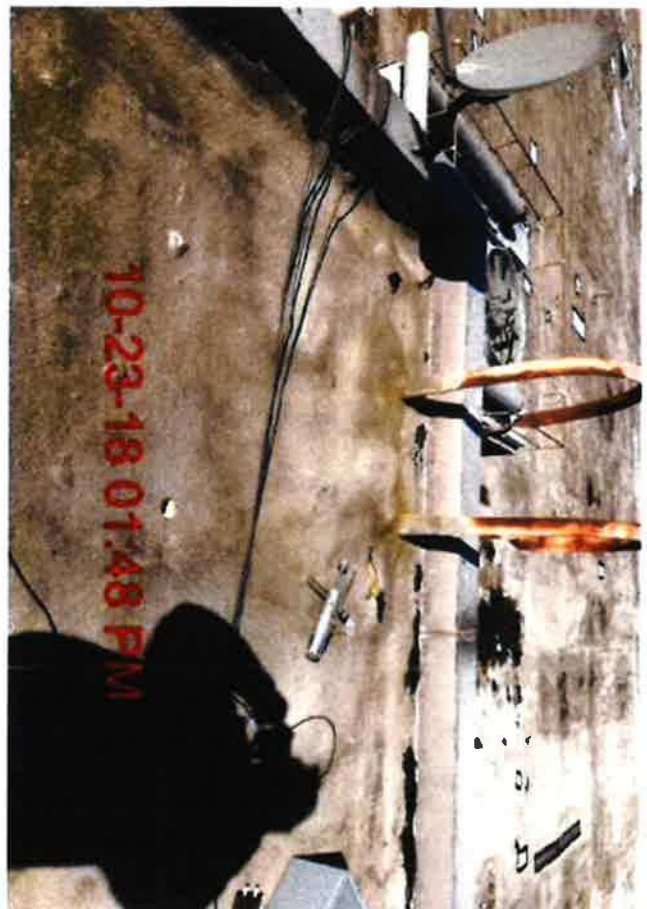
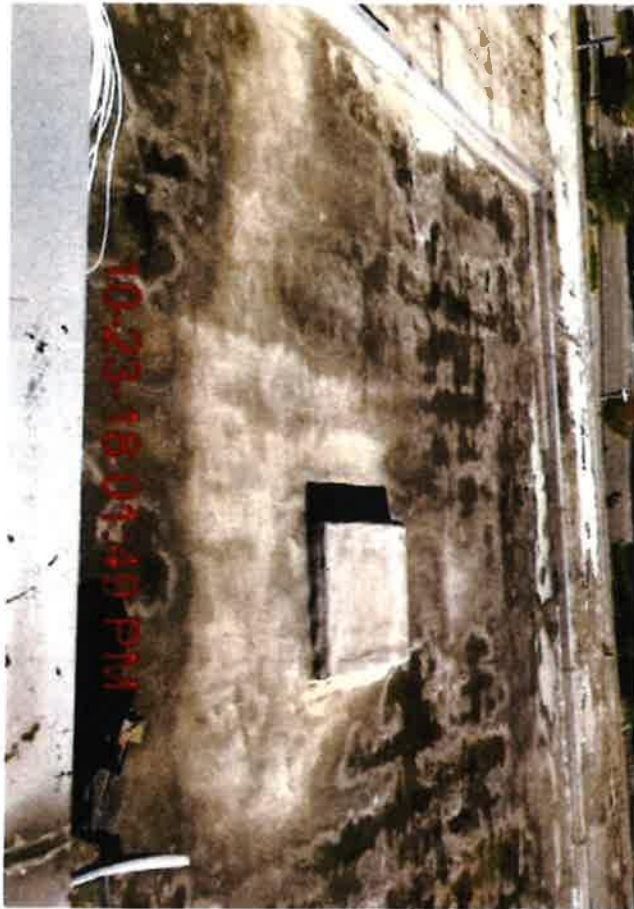
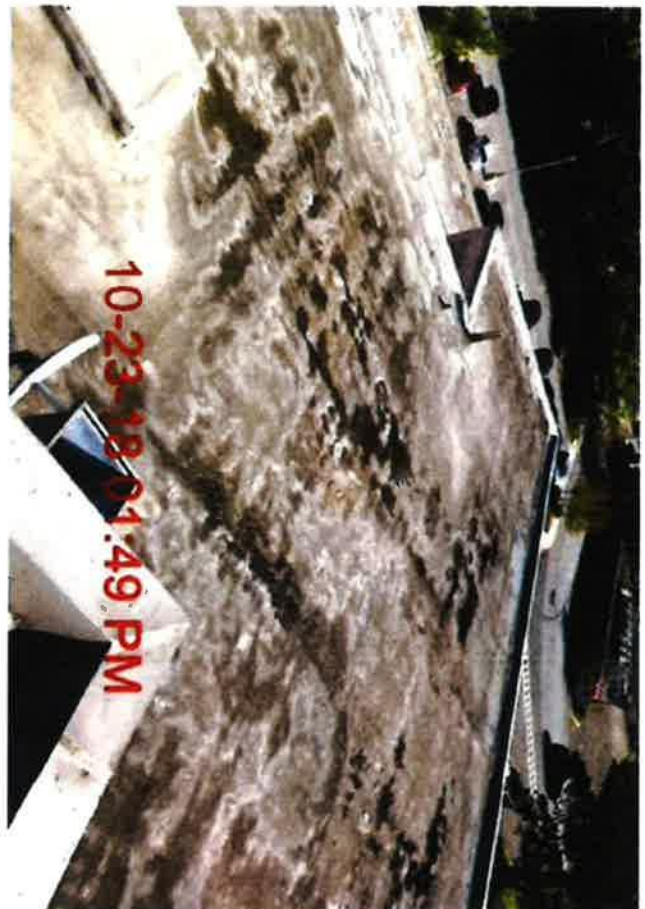
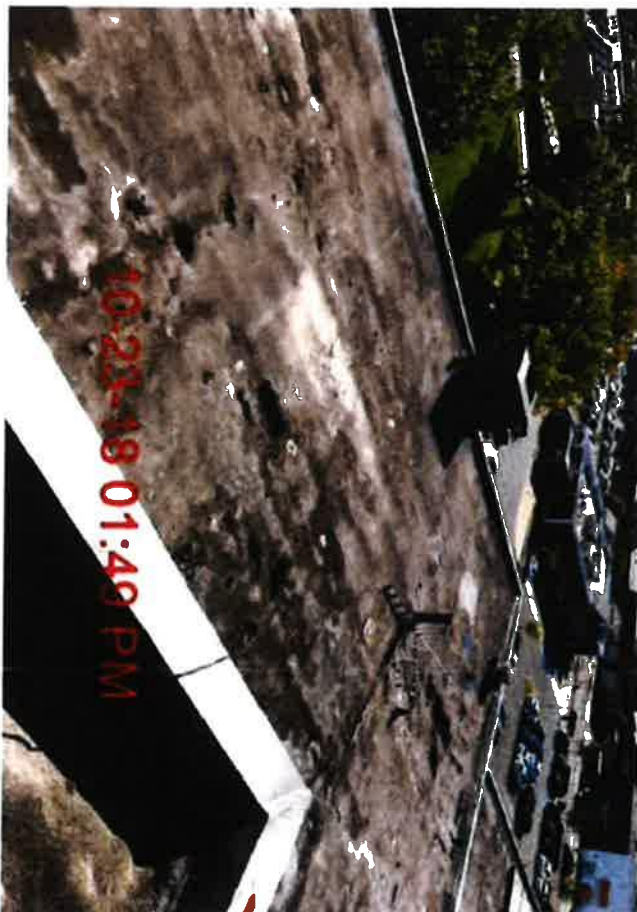
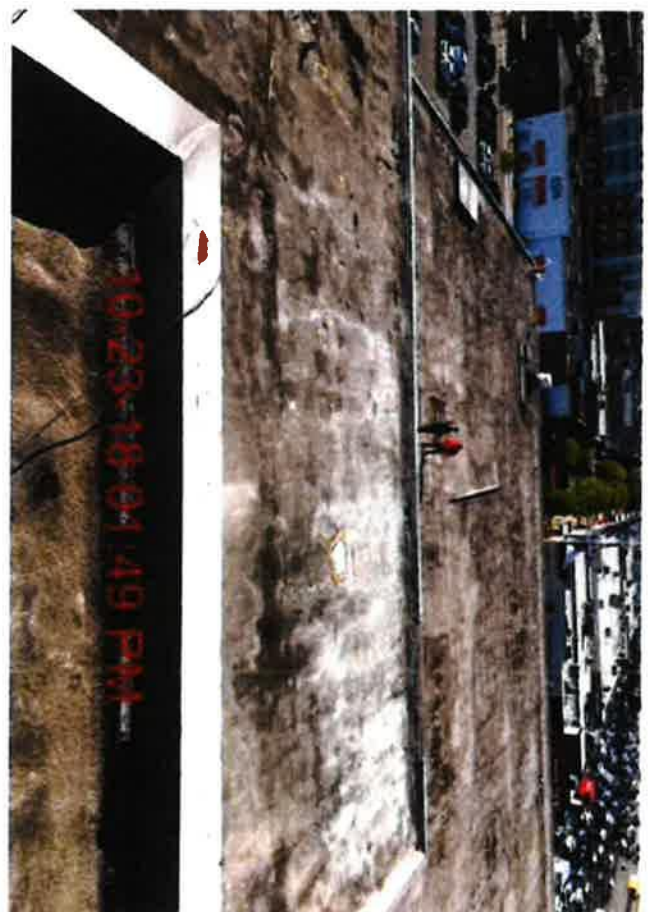
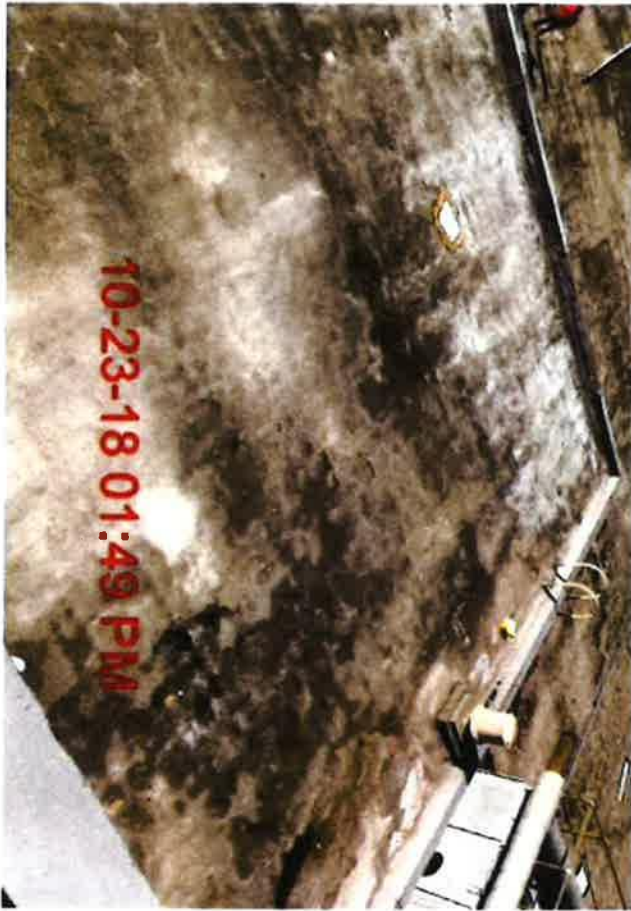
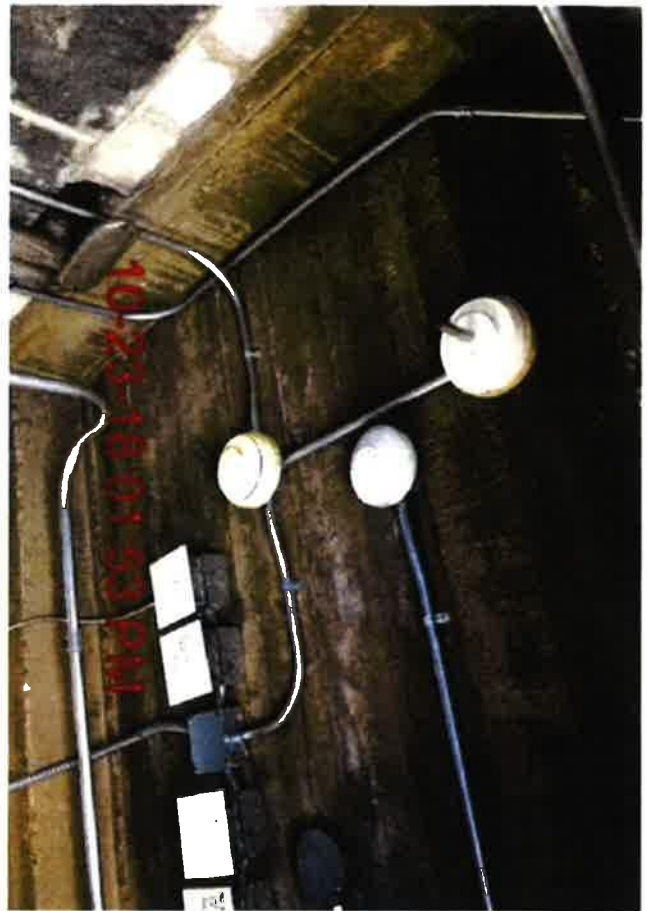
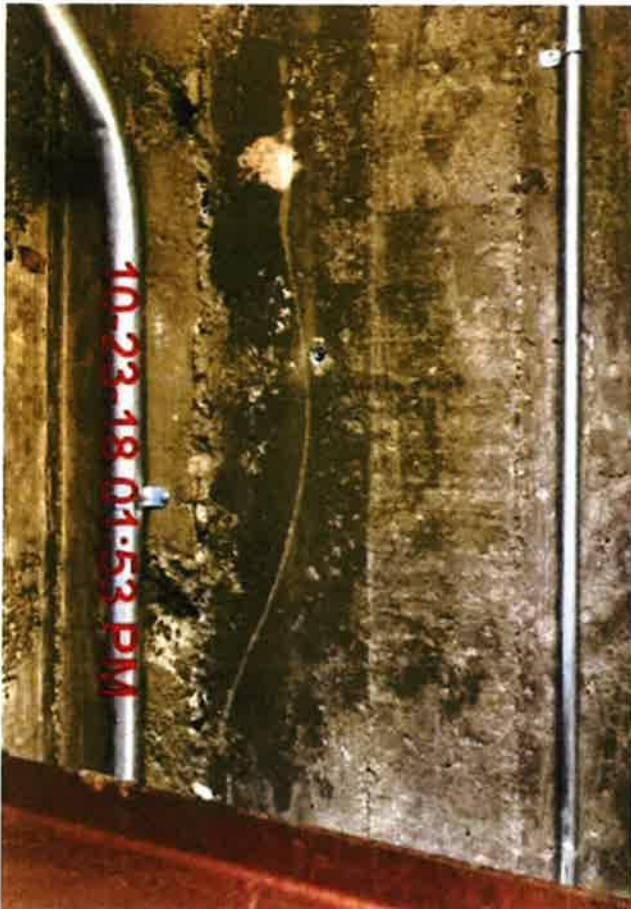
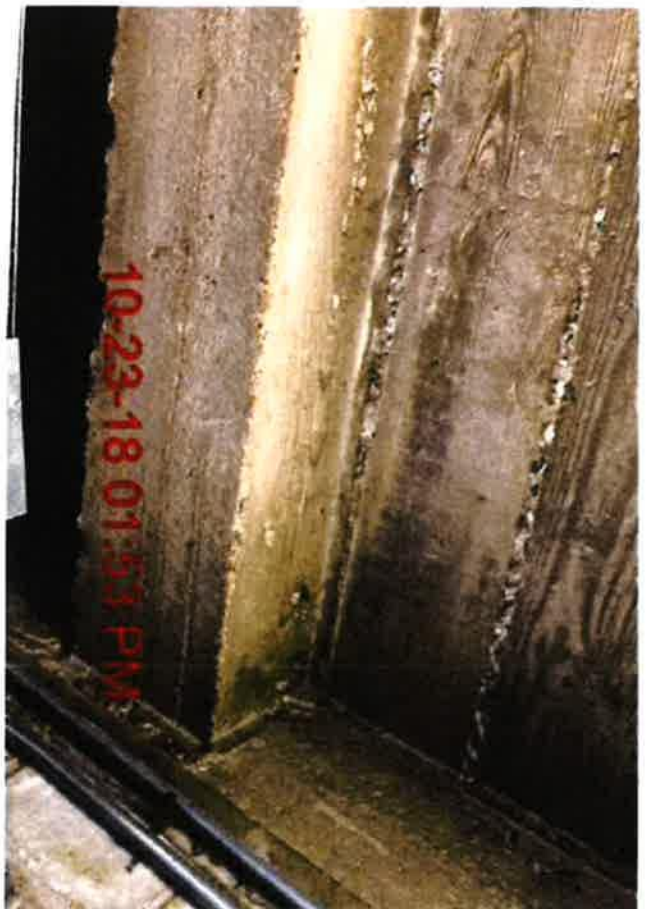
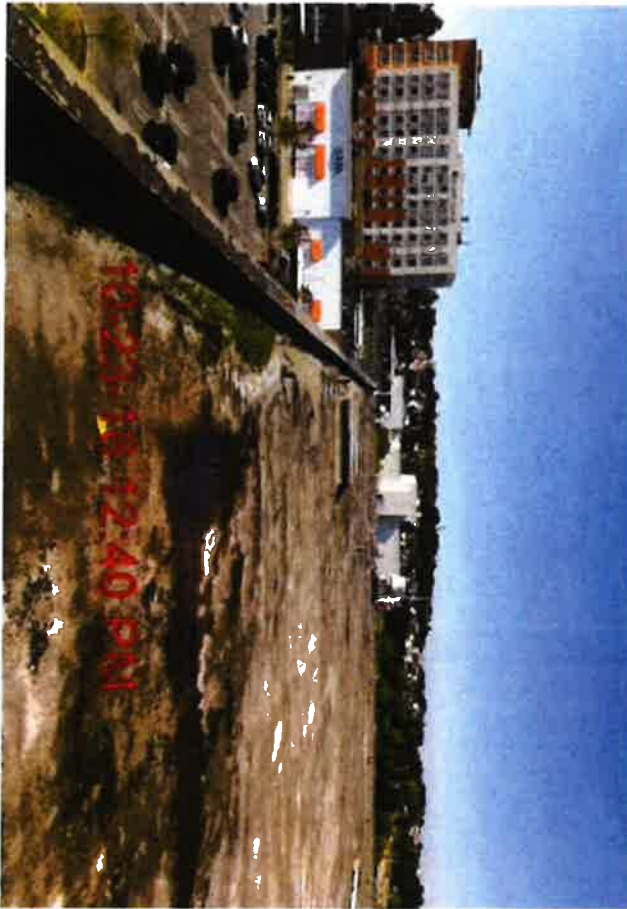
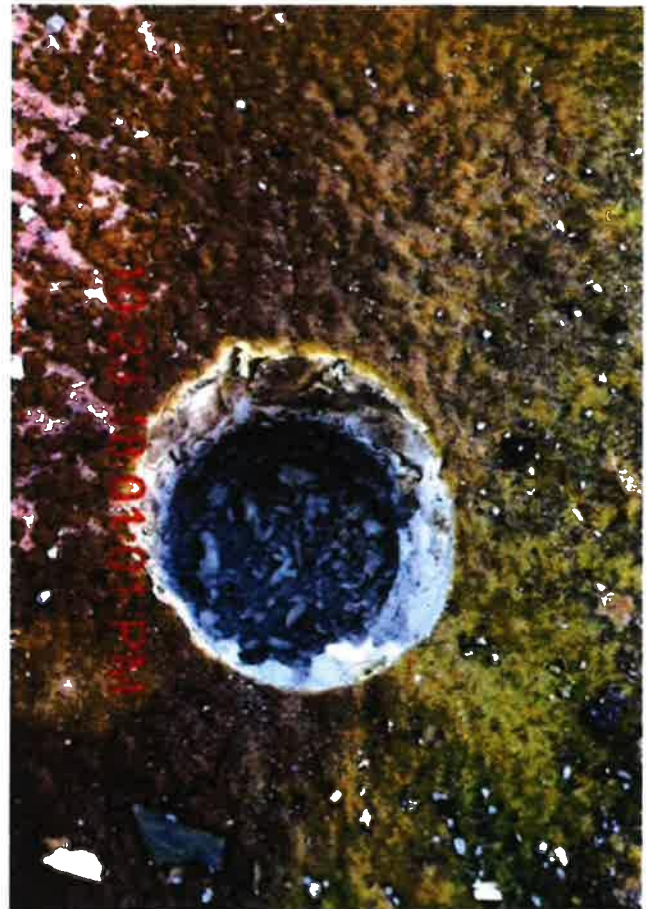
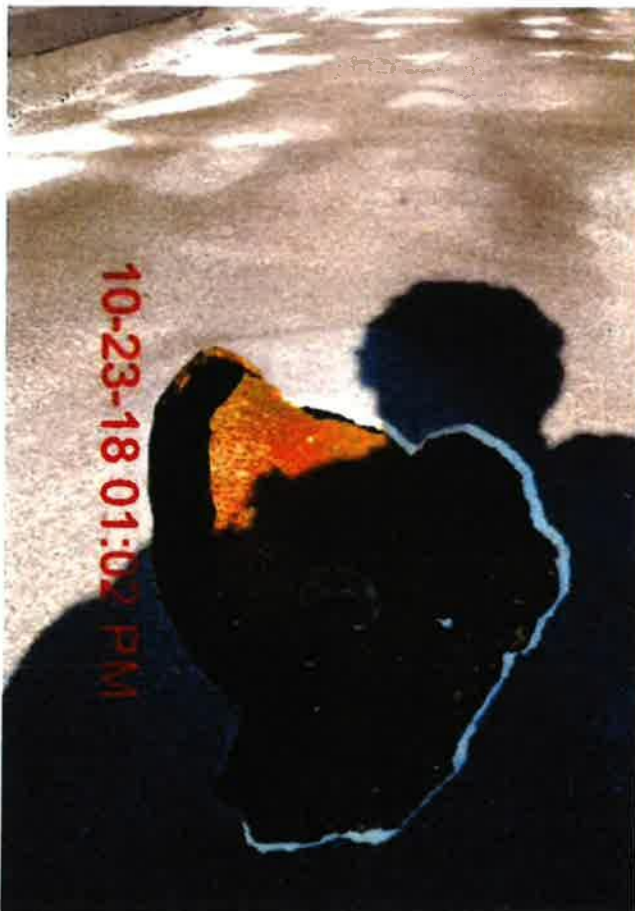
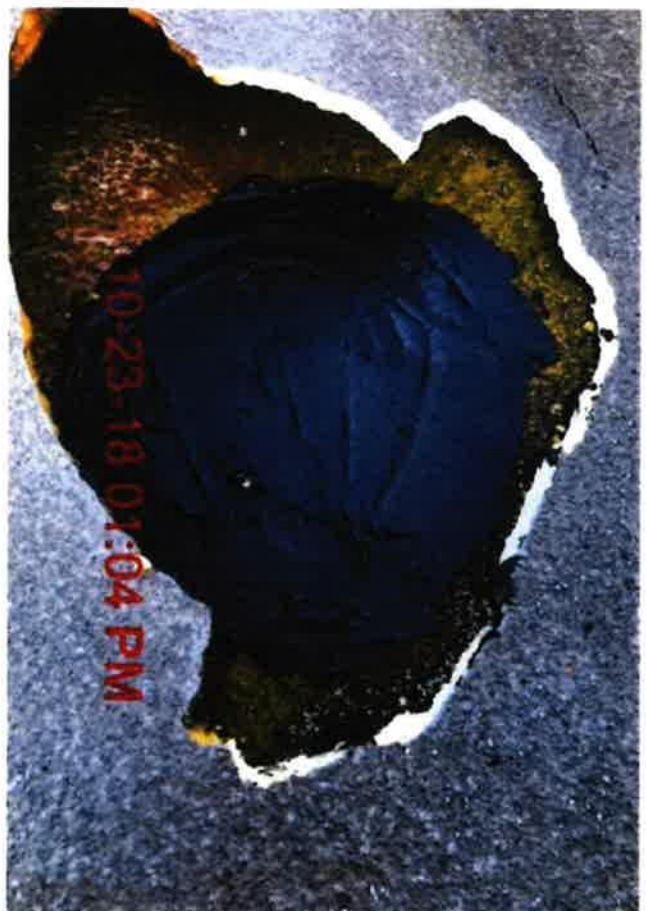
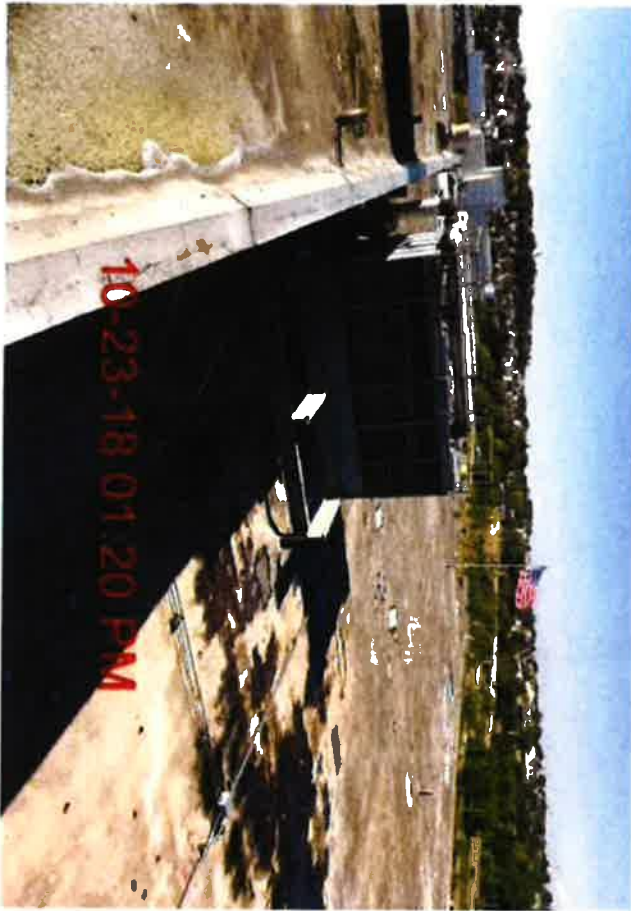
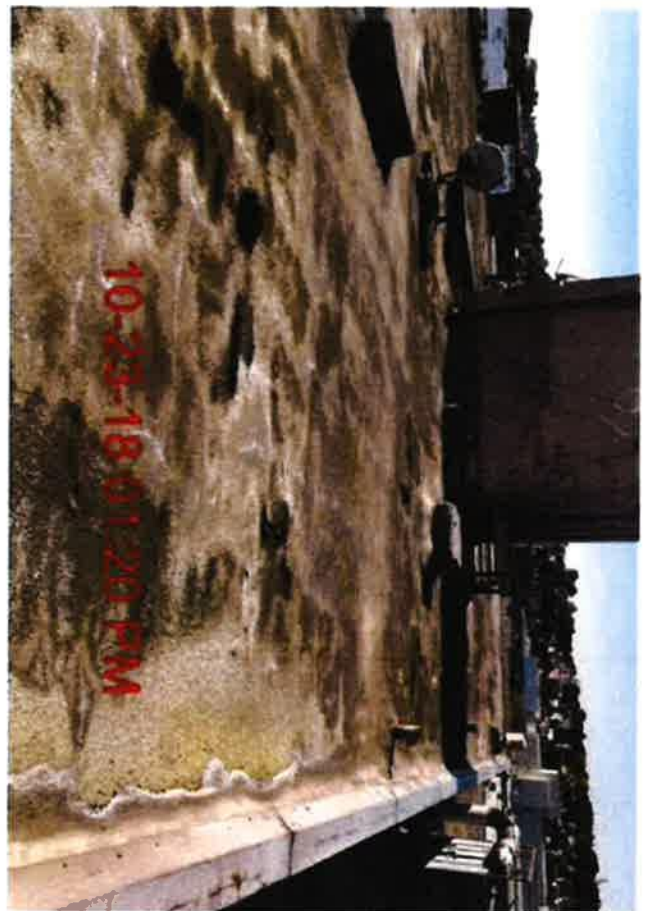
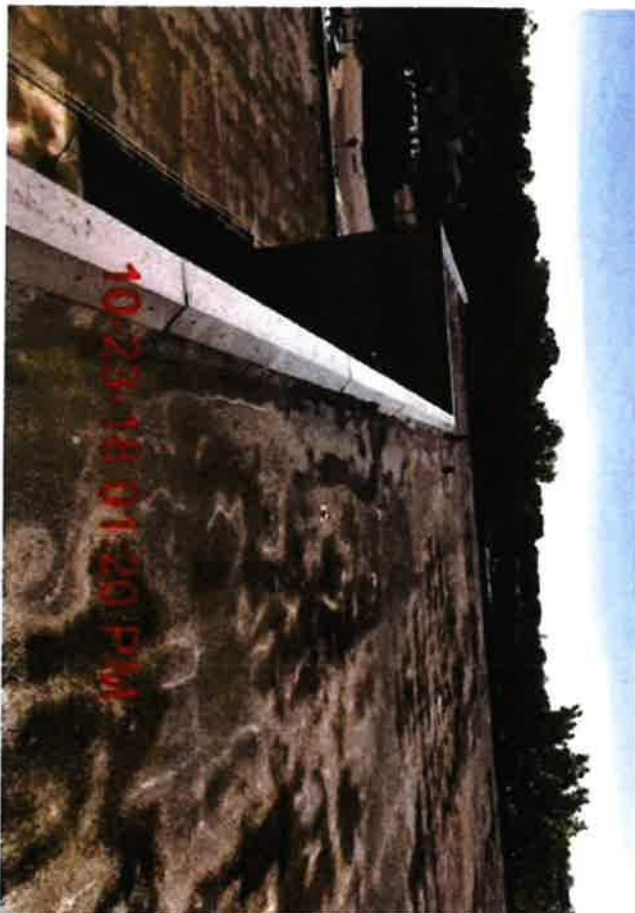
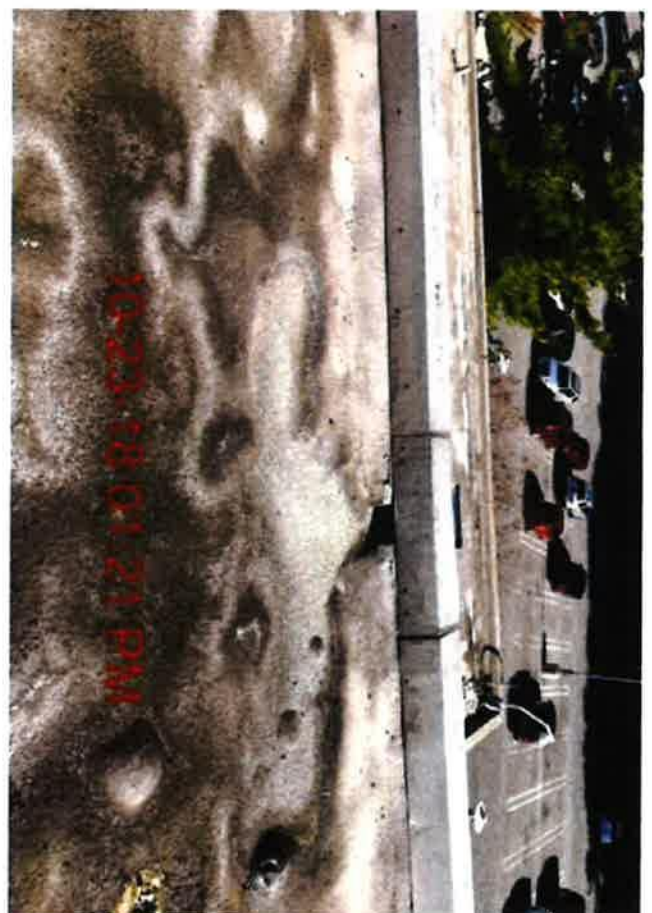
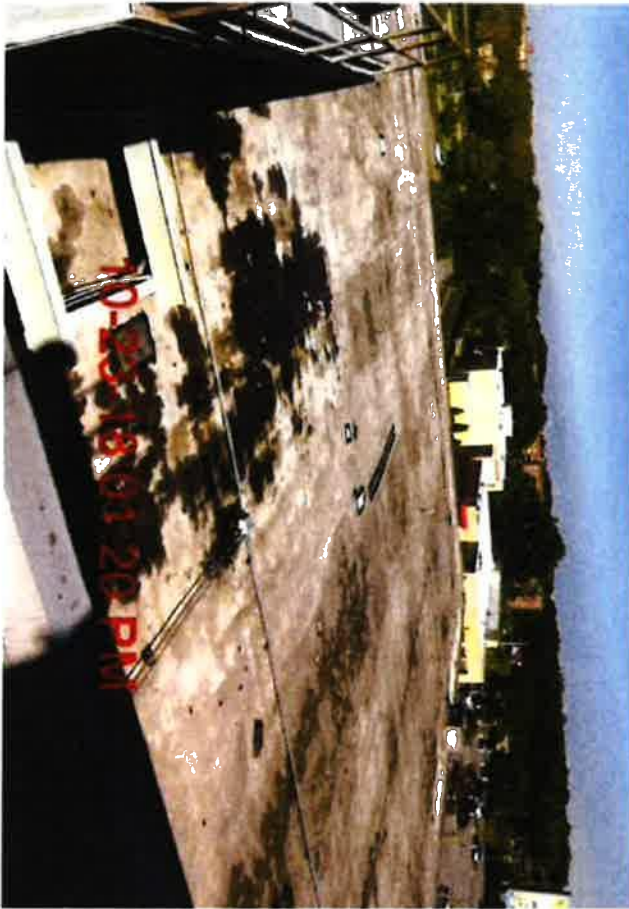
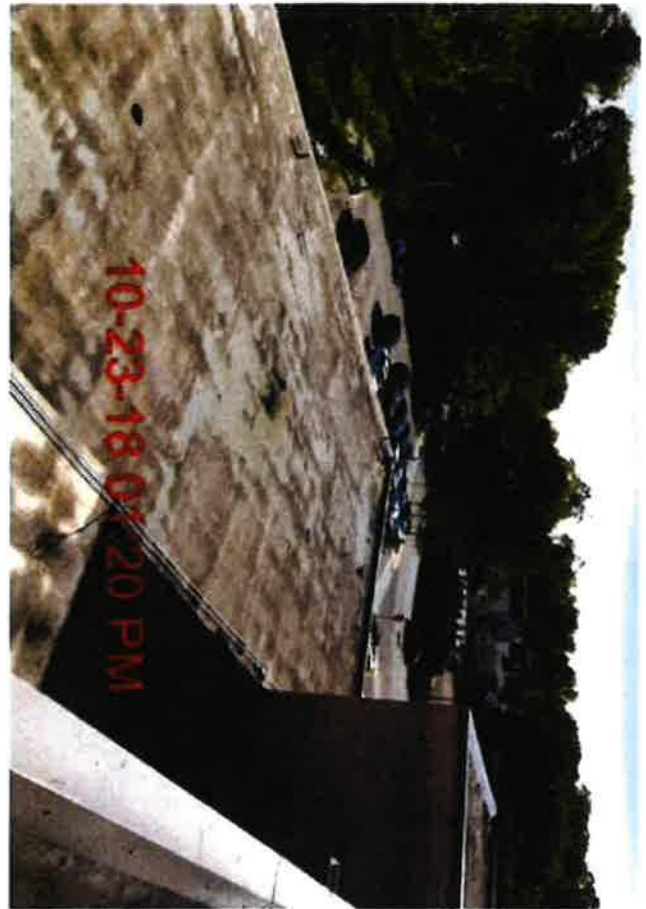
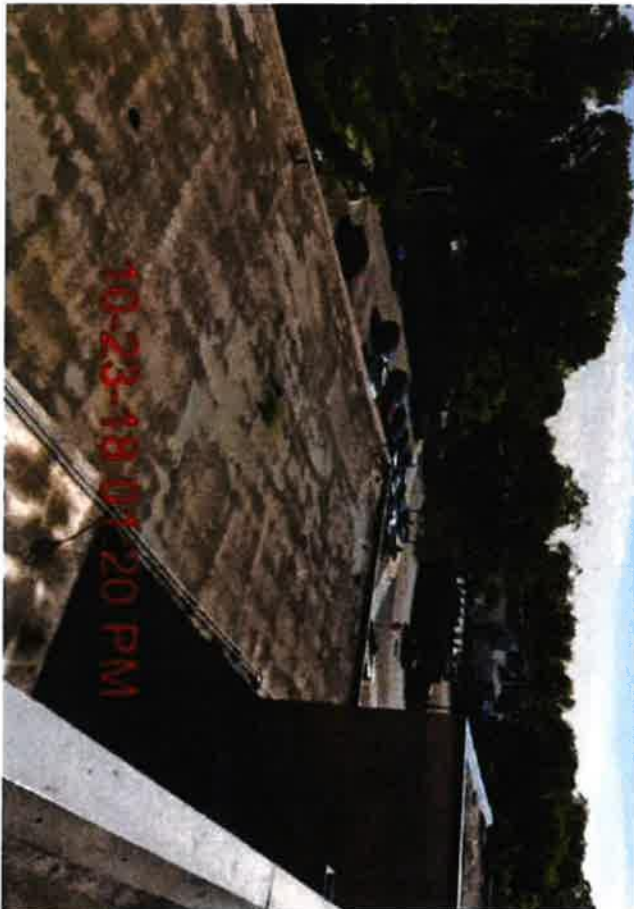
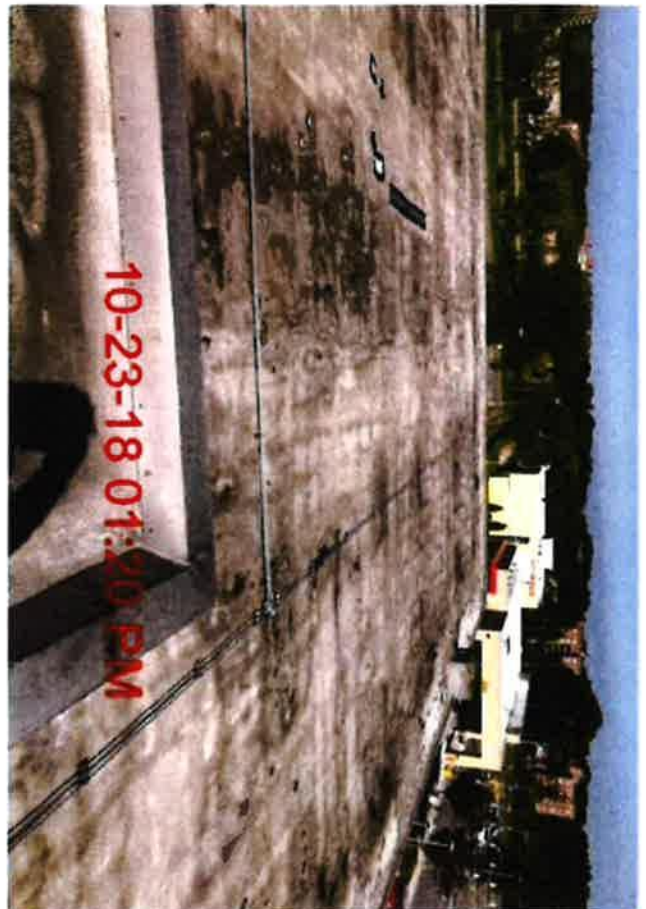
Visual observations and test samples revealed that this roof may have exhausted its life expectancy. Existing roof consists of a sprayed in place urethane foam roof. Top layer started to cup at numerous locations and have caused cracks and blisters throughout the roof.

Metal cap appeared in bad condition and started to lift as evidenced from pictures. Ponding water was also visible at many locations. Our test cuts revealed that existing insulation thickness varies from 2" to 3" at location that were tested.

For best results we recommend that entire roof to be removed and replaced. New roof assembly should incorporate local code requirements for R-Value and wind design.

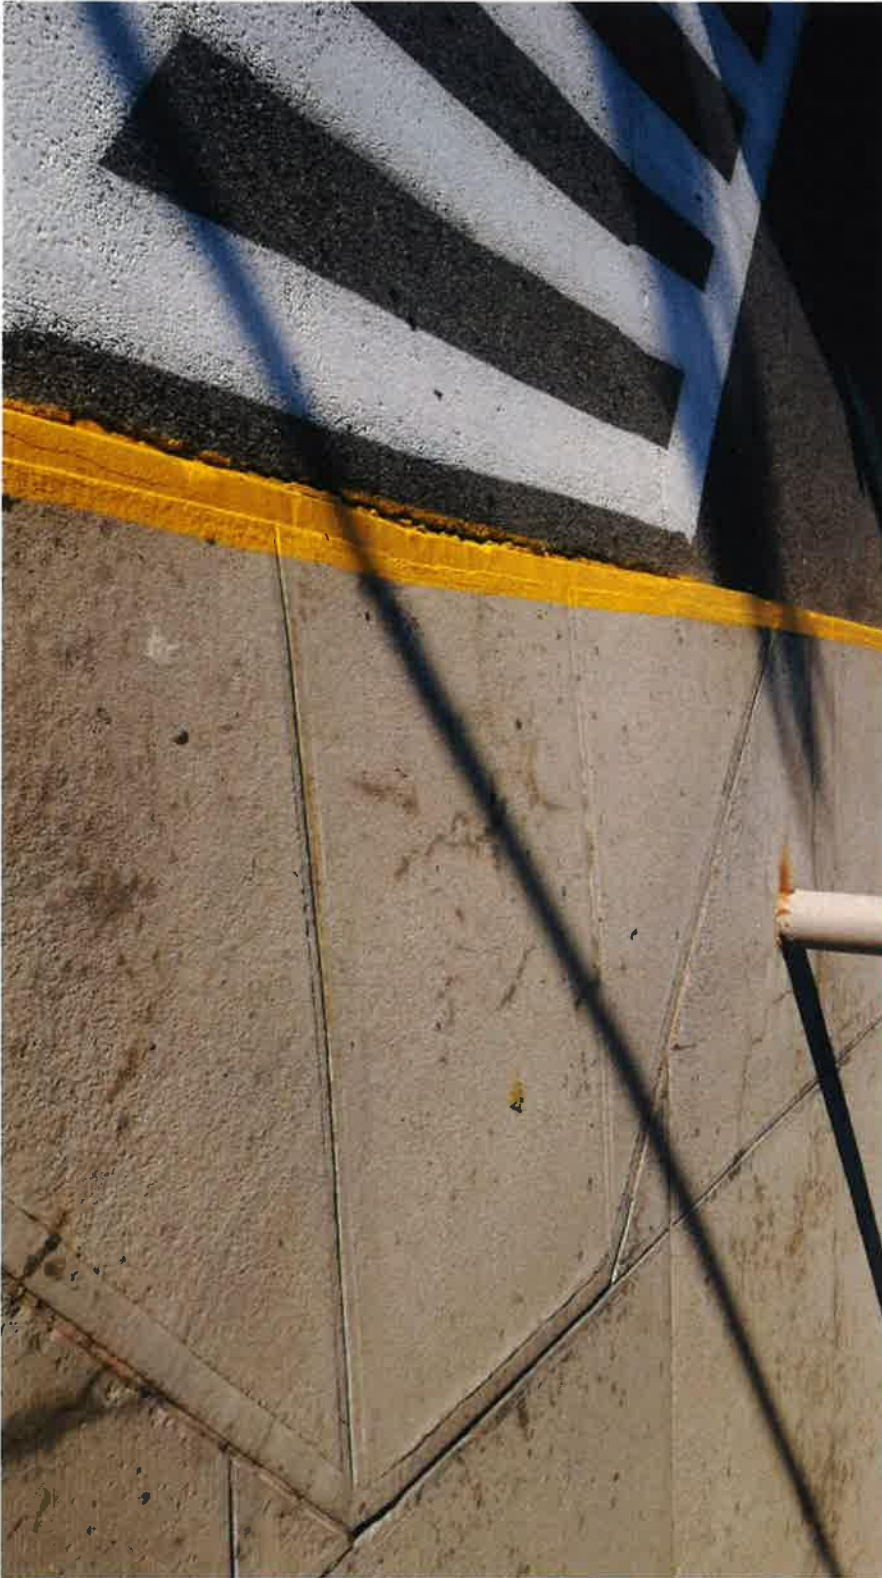
ADA Curb ramp not compliant with ADA requirements
1 Running slope Non-compliant
2 cross slope Non-compliant
3 transition gap Non compliant

Inspector's Recommendations
1 Remove and replace to comply with the latest ADA requirements
2 Remove and replace to comply with the latest ADA requirements
3 Remove and replace to comply with the latest ADA requirements

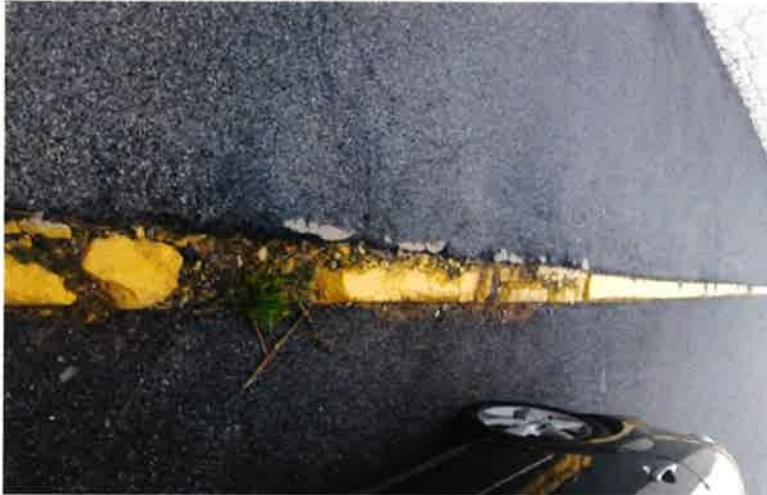
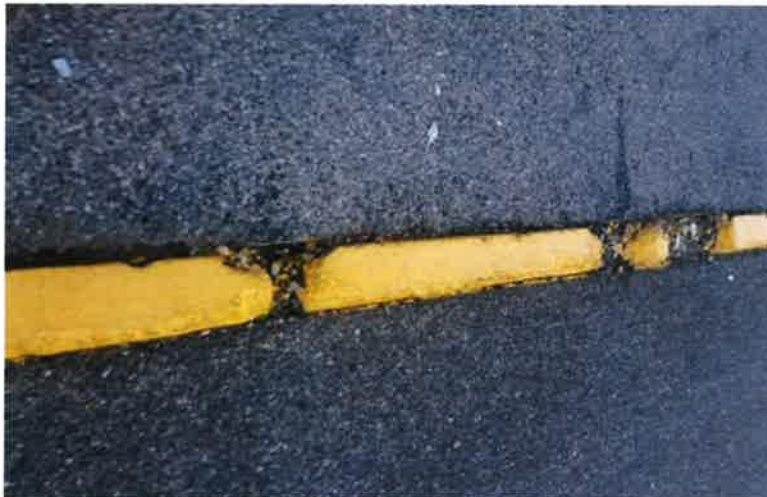
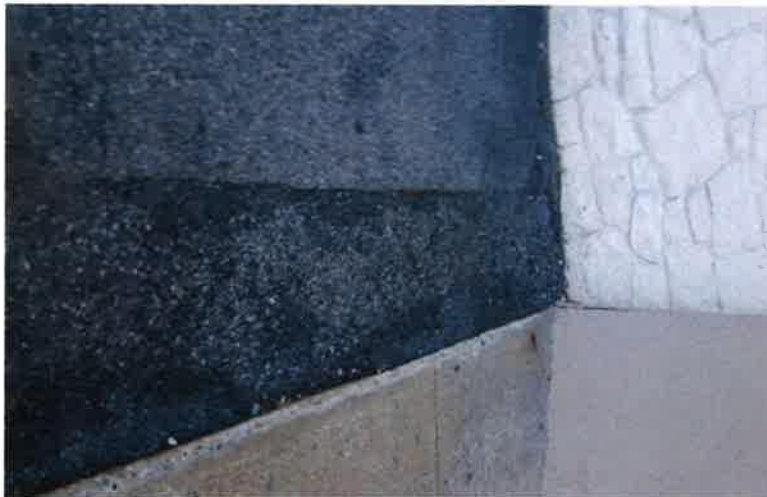
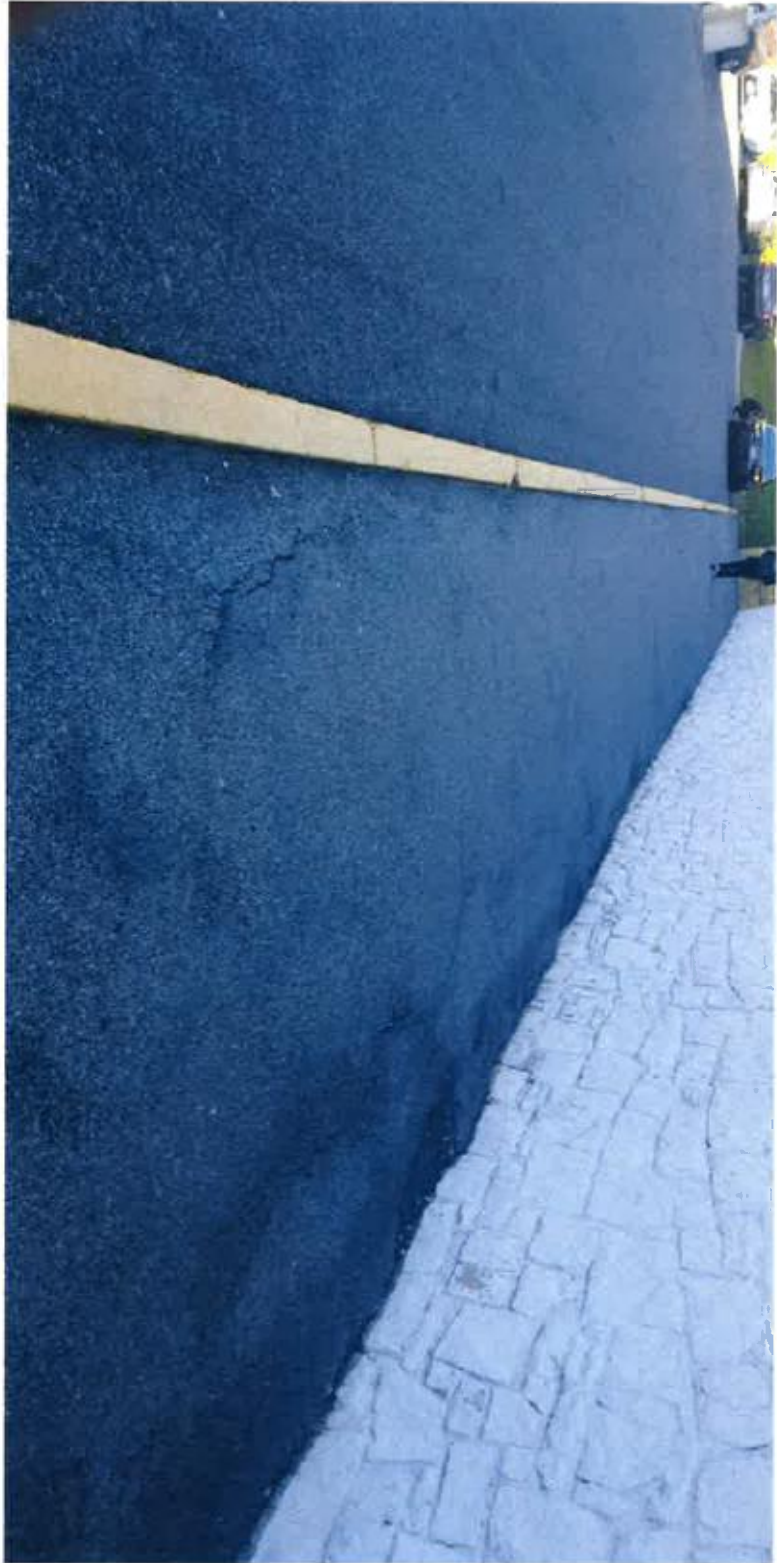
Side walk curb and black top side walk

1. Missing
2. Damage
3. Trip hazards
4. sunken curbs

- Inspector's Recommendations
1. Replace curb and sidewalk to comply with code
 2. Replace curb and sidewalk to comply with code
 3. Replace curb and sidewalk to comply with code
 4. Replace curb and sidewalk to comply with code
- Repair should be addressed*
